LAGUNA II ESPACE ESPACE IV VEL SATIS AVANTIME

fitted with G9T 702 - 710 - 712 - 742 engine

TDC SENSOR

OTS: 0A99

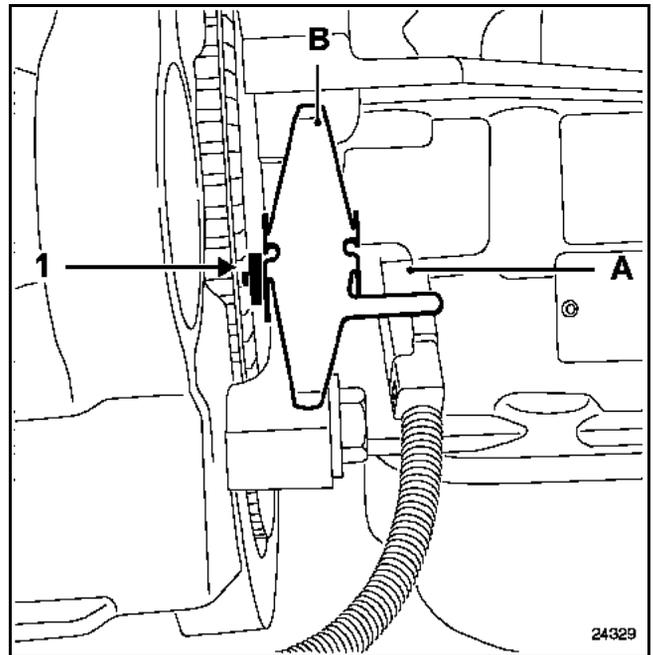
Fig. 1

A - TDC sensor

B - Mounting clip

1 - Contact between the flywheel and the TDC sensor

- Remove the engine undertray.
- Replace the TDC sensor (A) and its mounting clip (B) (Fig. 1).

IMPORTANT: the TDC sensor should slide freely in the clip when it is fitted.

- The TDC sensor **MUST** butt up to the flywheel (1) (Fig. 1).

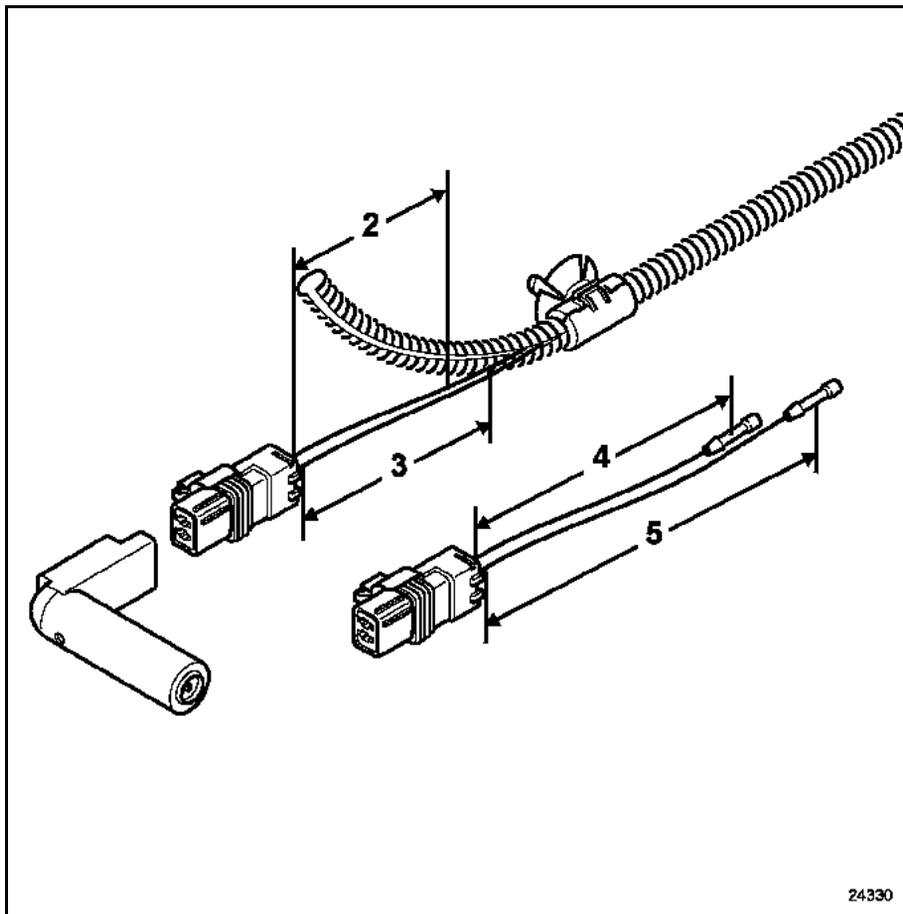
Fig. 2

- 2 – length of track no. 1 wire on old connector: 120 mm
- 3 – length of track no. 2 wire on the old connector: 160 mm
- 4 – length of track no. 1 wire on new connector: 140 mm
- 5 – length of track no. 2 wire on new connector: 180 mm

- Replace the TDC sensor connector on the engine harness:
 - Remove the annealed sheath from the TDC connector wiring harness.
 - Cut the wire of track no. 1 at **120 mm (2) (Fig. 2)** from the rear of the TDC sensor connector.
 - Cut the wire of track no. 2 at **160 mm (3) (Fig. 2)** from the rear of the TDC sensor connector.

IMPORTANT: track allocations MUST be adhered to.

- Reconnect the sleeves of the new connector to the engine harness with a crimping tool.

- Shrink the sleeves with a hot air gun.
- Refit the annealed sheath.
- Reconnect the connector to the TDC sensor.
- Refit the engine undertray.
